Canoga Country Hills Estates

West Hills

Site Plan

Plate A

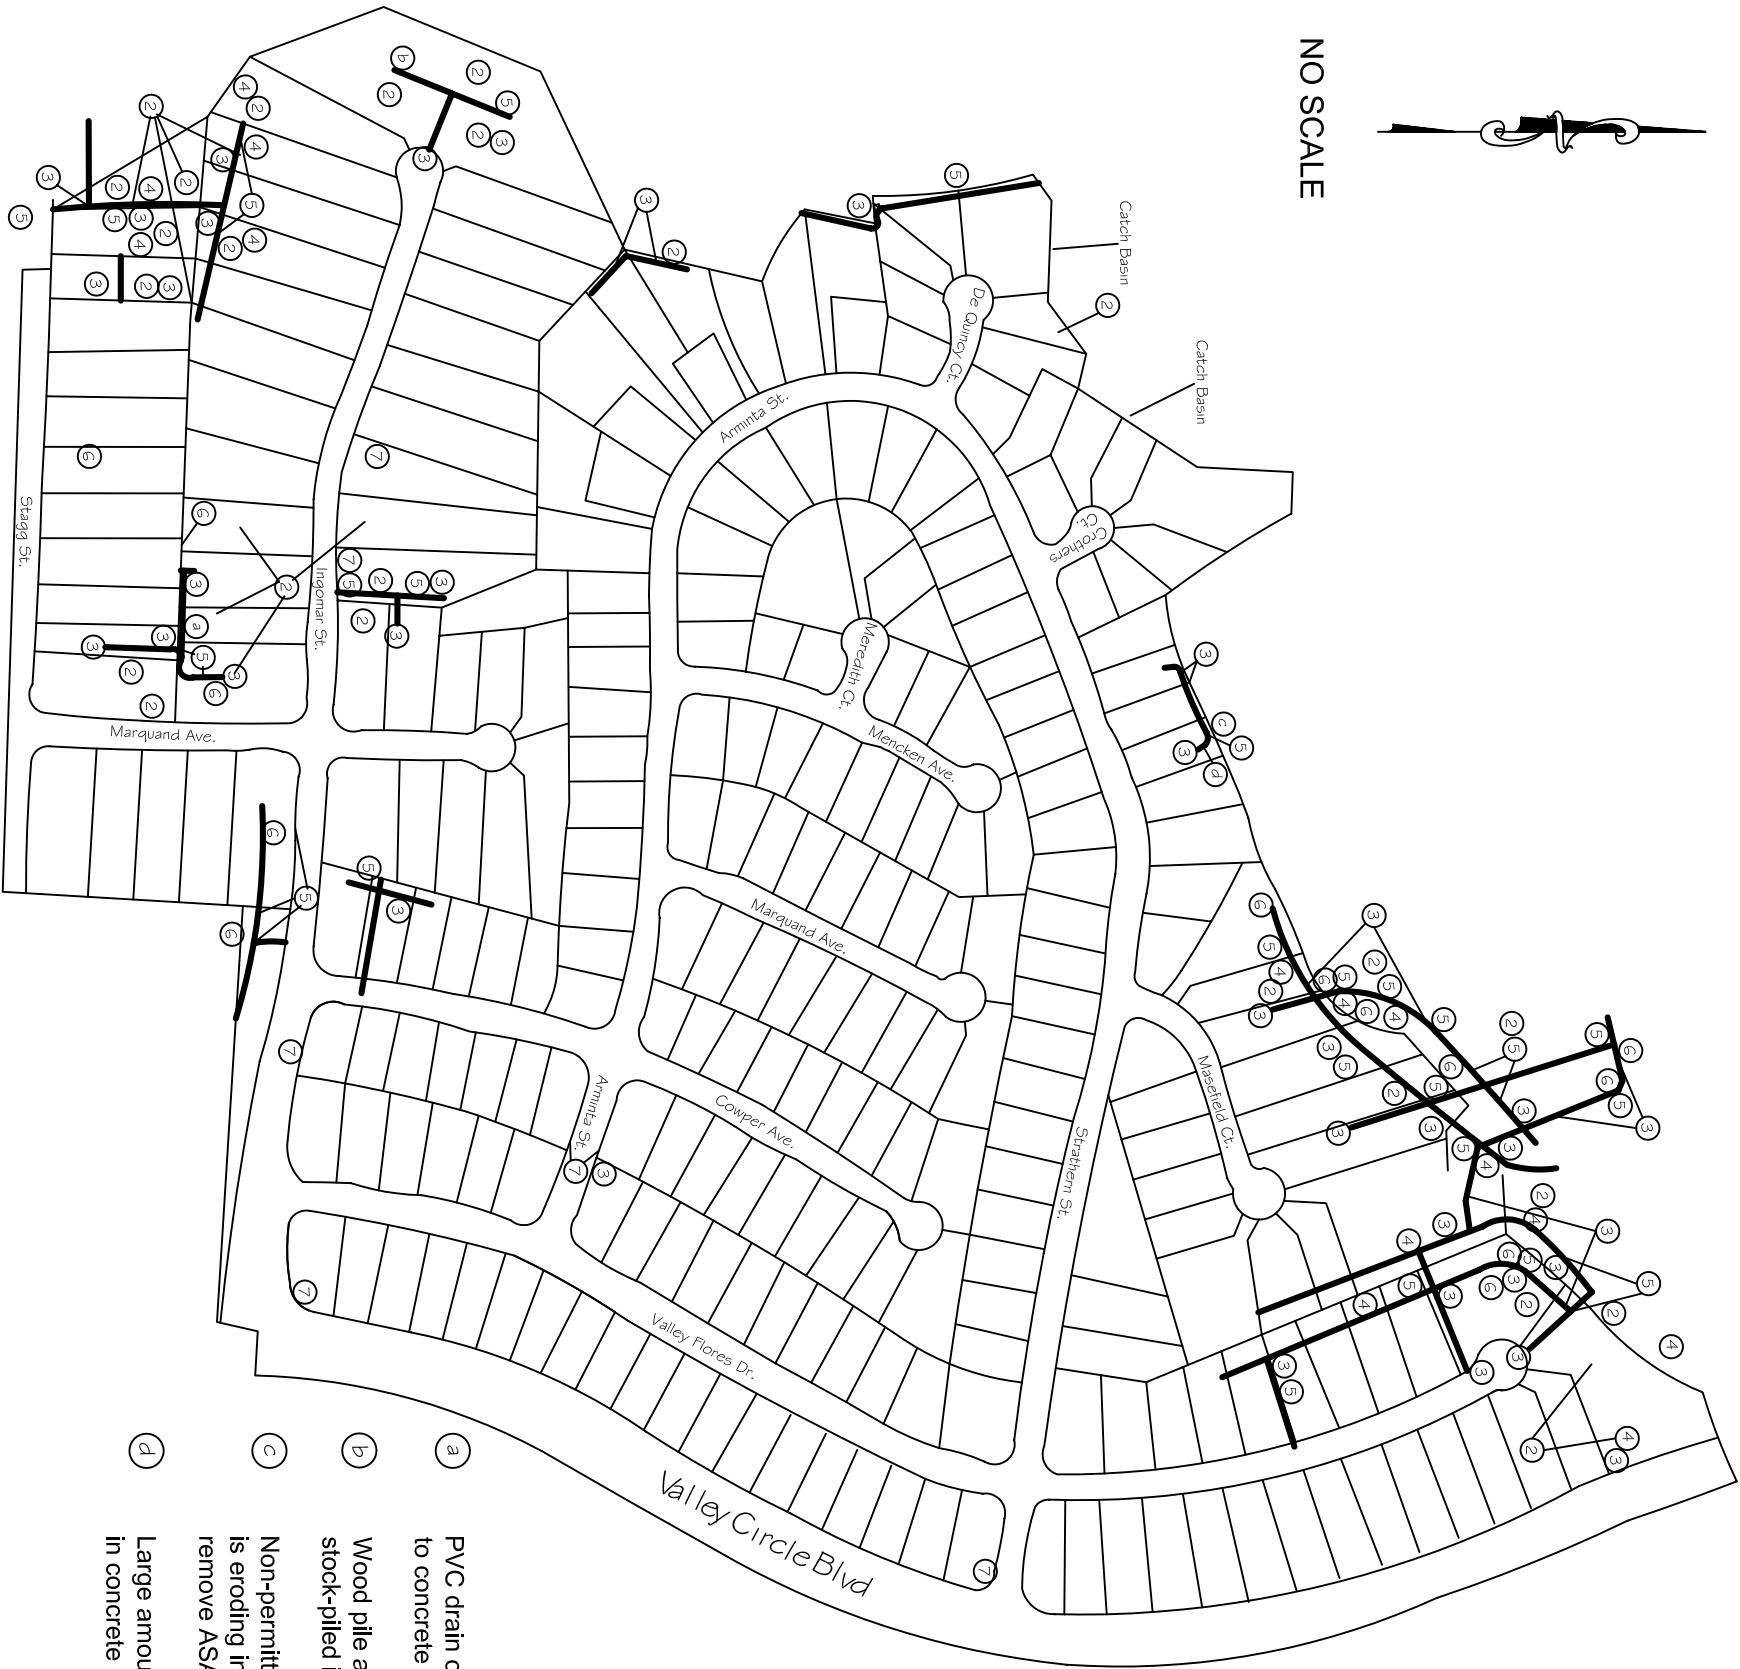
- ① Approximate location of distress to retaining walls
- ② Approximate location where groundcover was observed to be patchy, sparse, and/or dry.
- ③ Approximate location of moderate to heavy debris in terrace drains, down drains and swales.
- ④ Approximate location where evidence of burrowing animals was observed.
- ⑤ Approximate location where moderate to large size cracks were observed.
- ⑥ Approximate location where erosion was observed.
- ⑦ Approximate location where efflorescence was observed.
- ~~7~~ Approximate location of terrace drains, down drains, and/or swales.

- a PVC drain outlets onto slope; extend to concrete swale.
- b Wood pile associated with construction stock-piled in swale, remove ASAP.
- c Non-permitted graded batting cage is eroding into concrete swale; remove ASAP.
- d Large amounts of trash debris observed in concrete swale; remove ASAP.

Not all areas of the development were accessible; therefore, it is reasonable to assume that the above conditions may exist in other areas. The areas denoted on the Site Plan are provided as general locators of observed distress.
